TS-AMD-87615-25  
May 1988

AERIAL PHOTOGRAPHIC ANALYSIS OF THE REFINED METALS CORP.

Indianapolis, Indiana

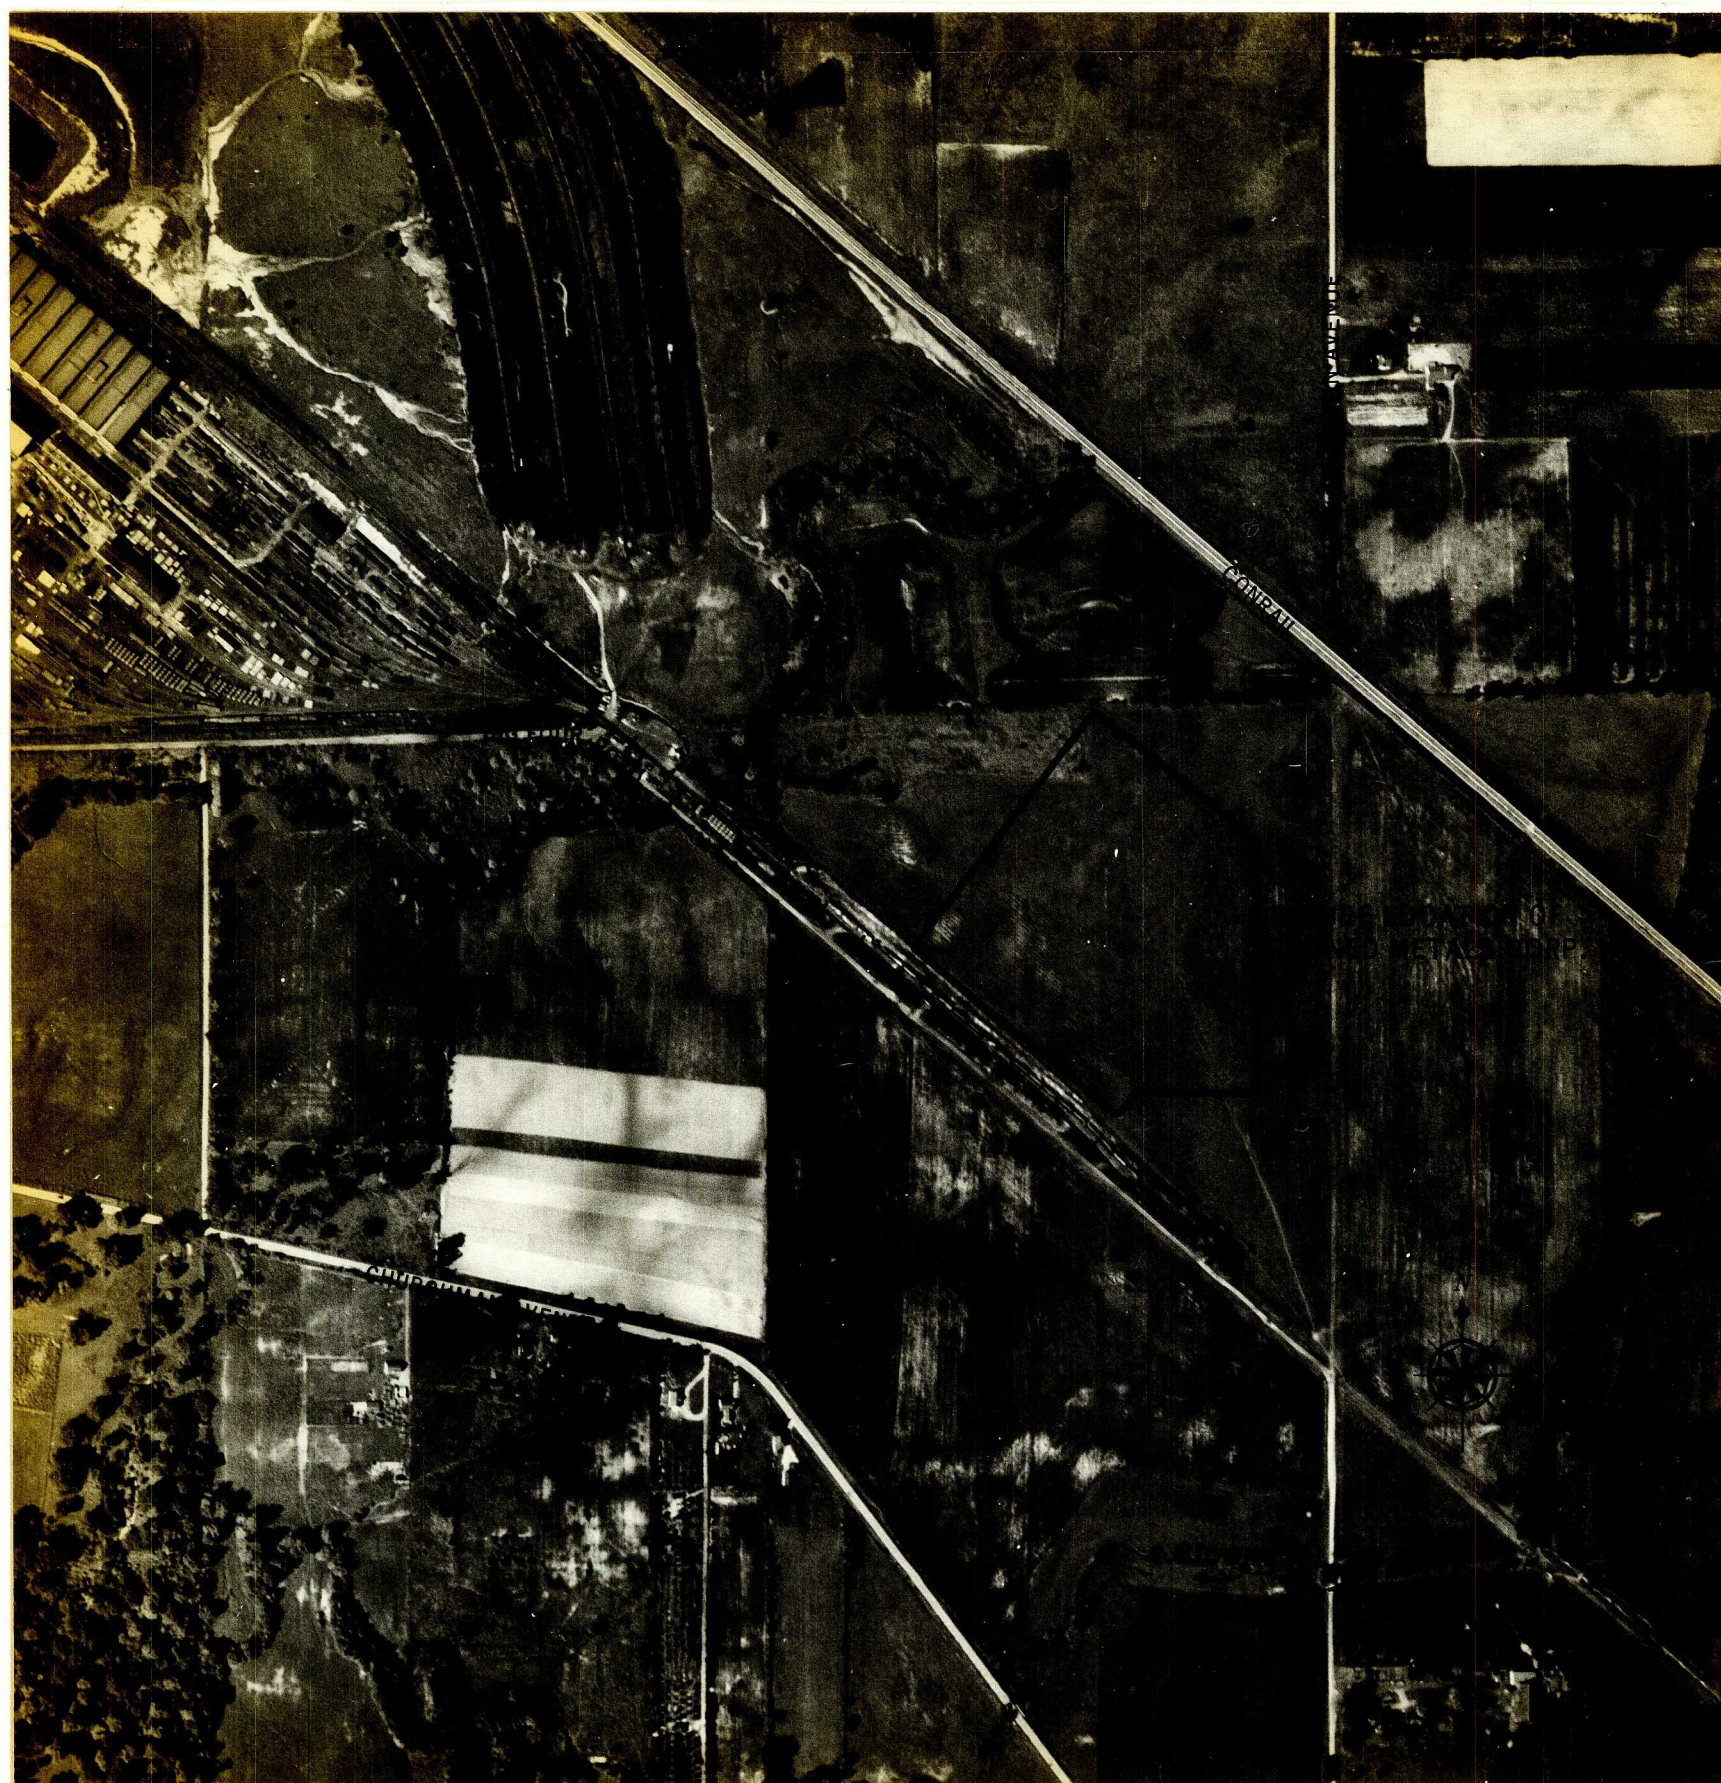
SEPTEMBER 6, 1950 (FIGURE 3)

The photo shows the future location of the Refined Metals Corp. There are no facilities as yet at the site. The drainage in the area includes Sloan Ditch and Beech Creek which flow in a southwesterly direction.

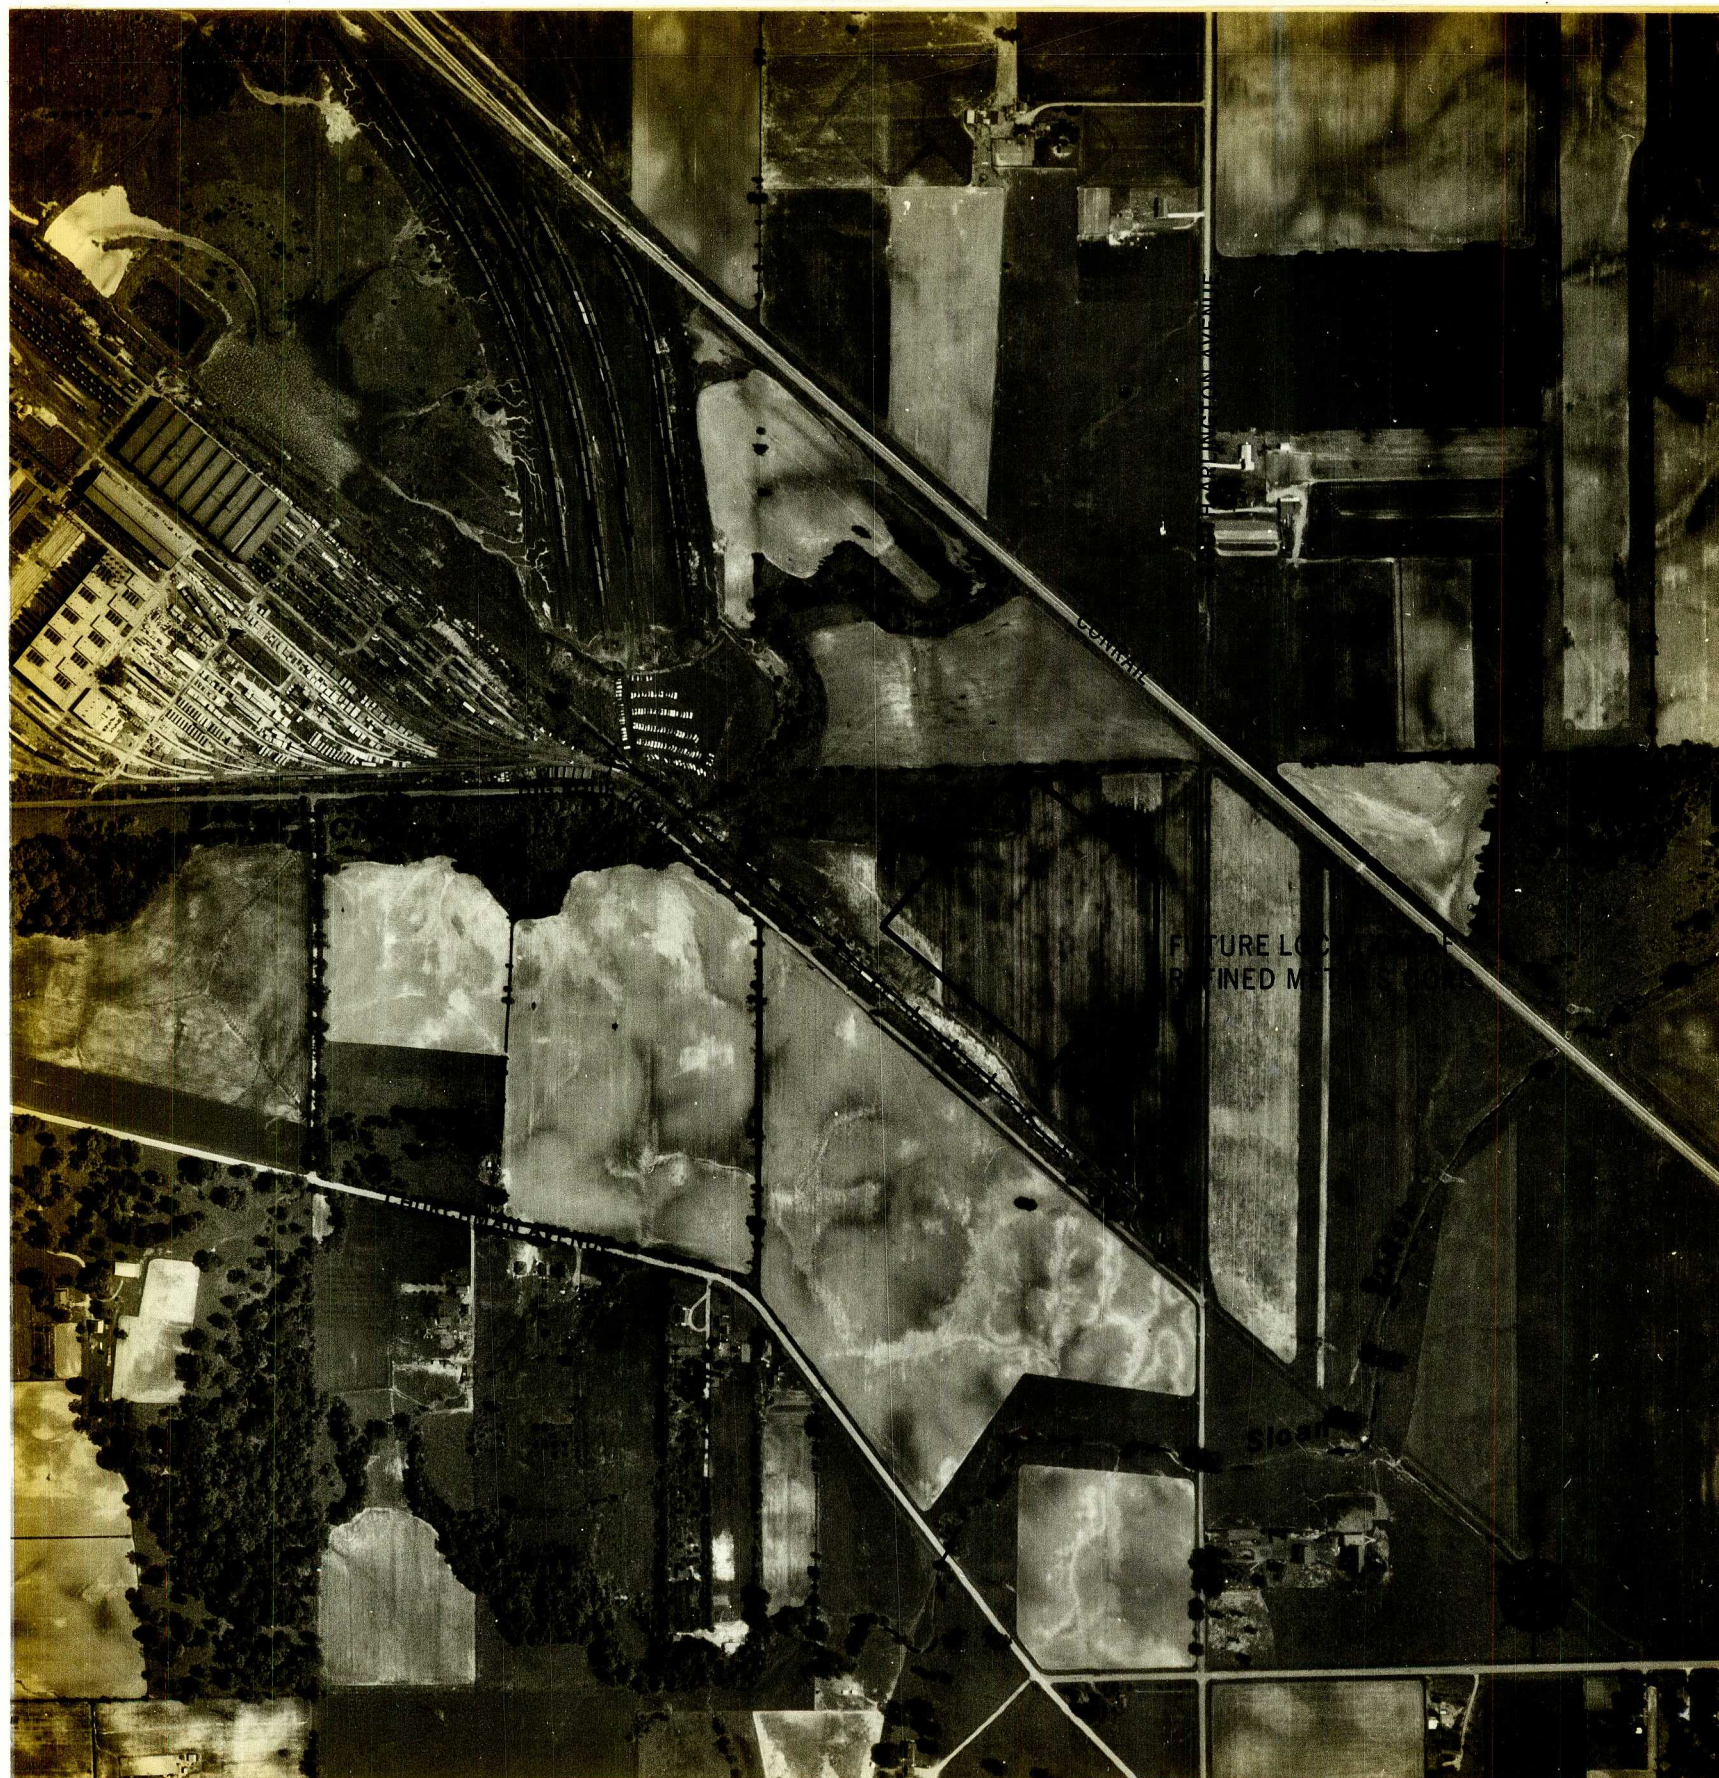
JUNE 6, 1956 (FIGURE 4)

This photo shows the future location of the Refined Metals Corp. There are no significant changes to the site or the surrounding area since it was observed on the 1950 photography (Figure 3).

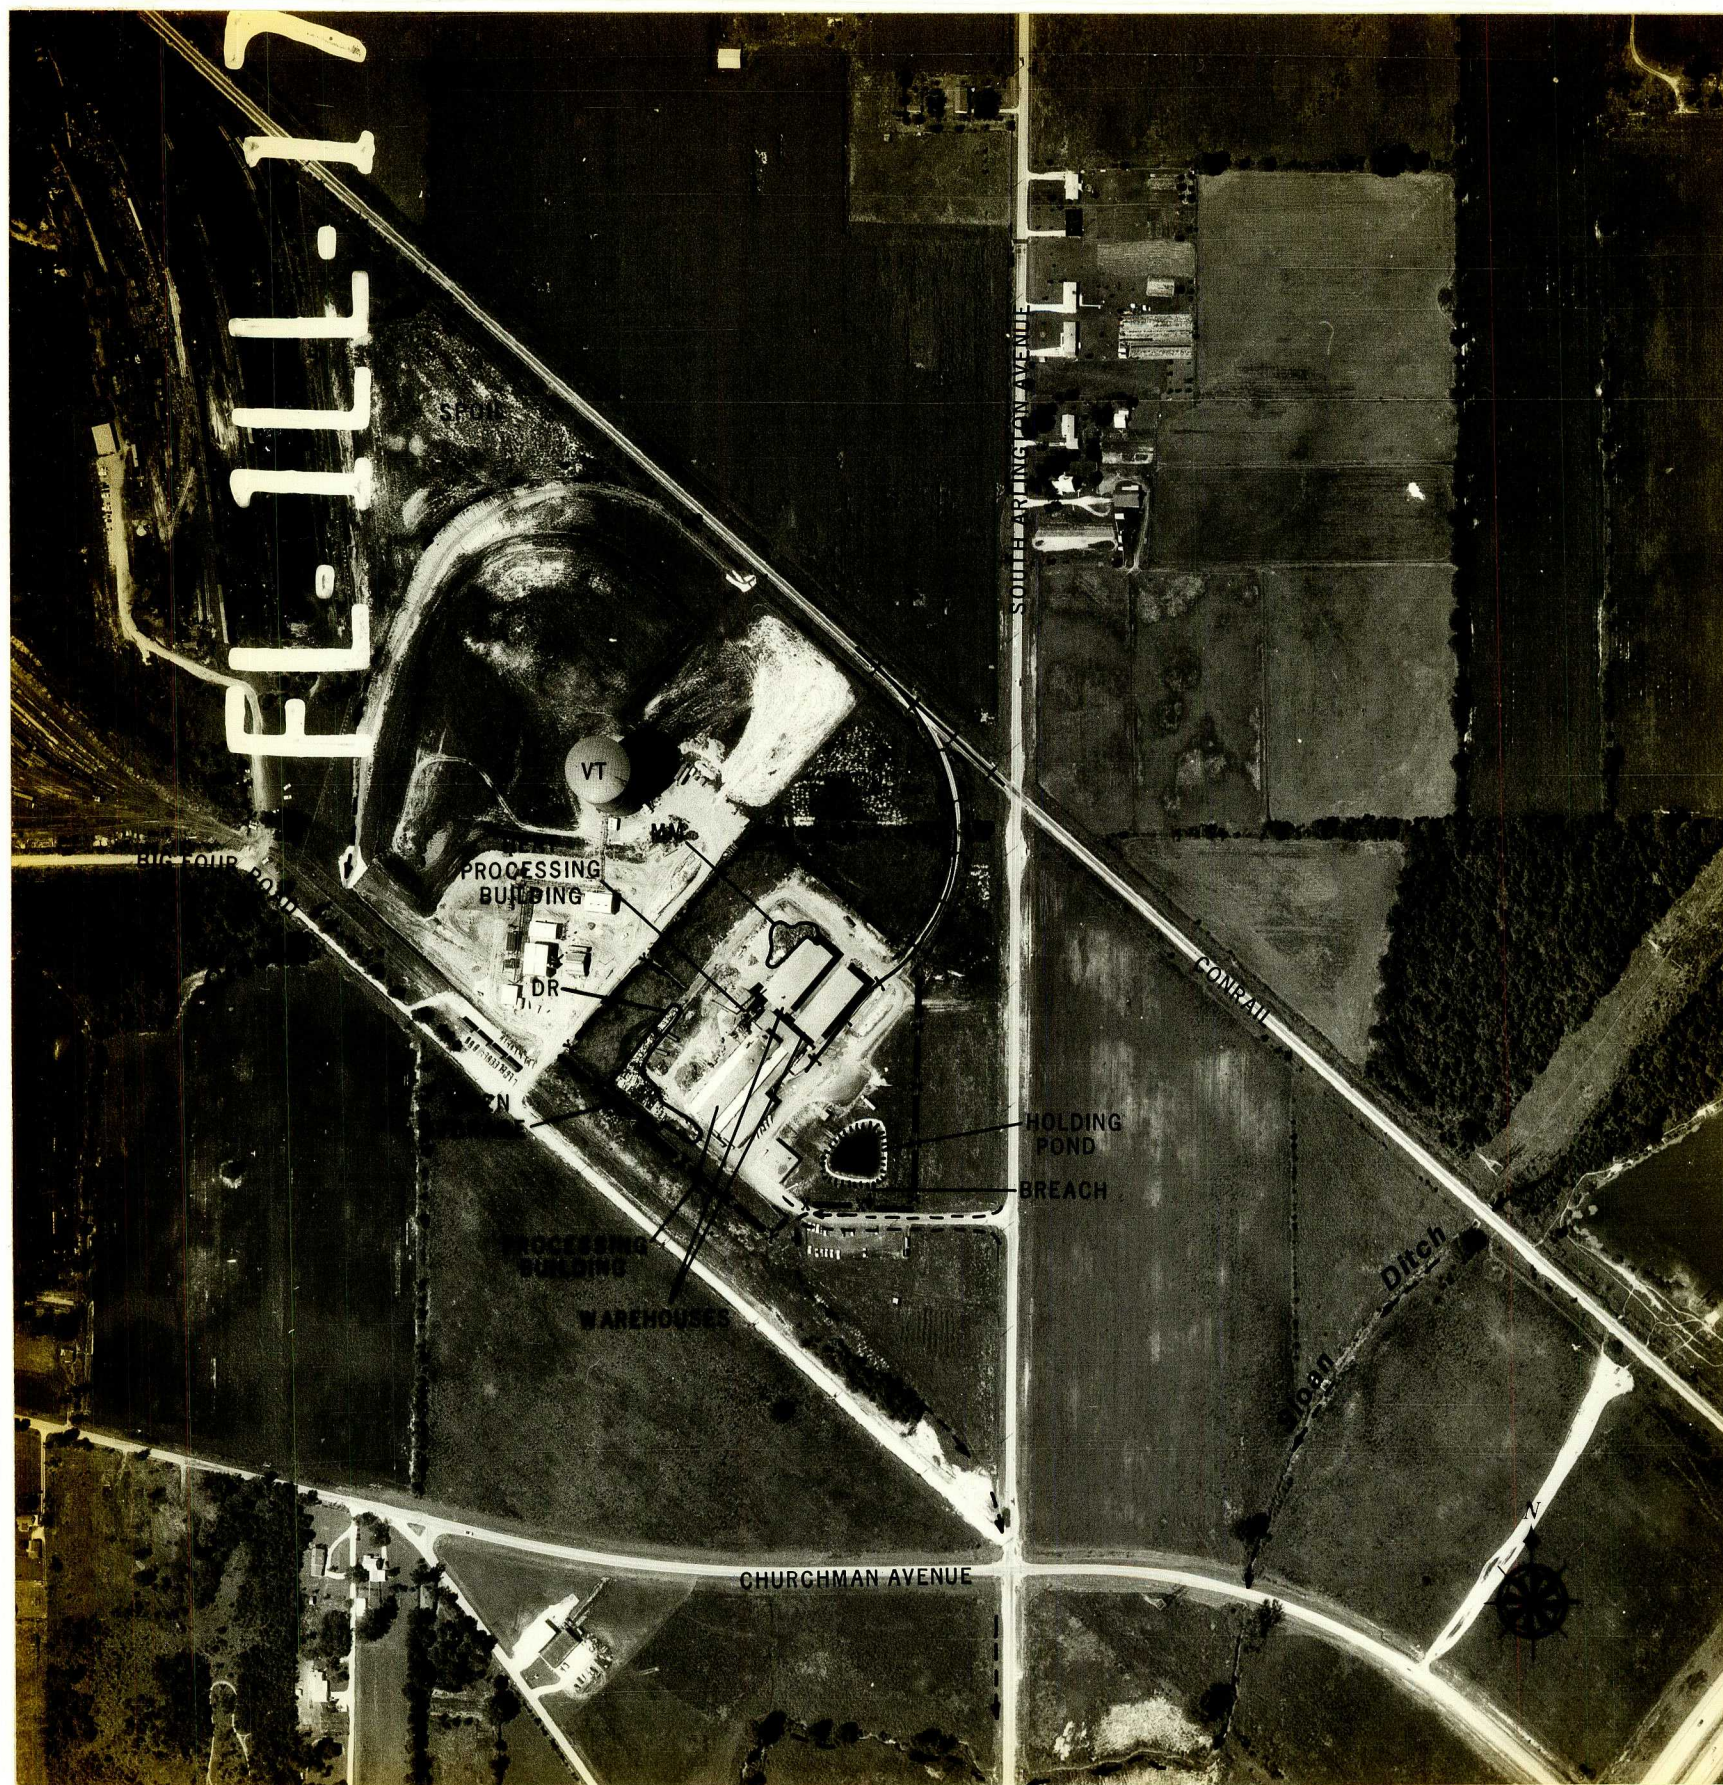
AUGUST 12, 1971 (FIGURE 5)

This photo shows the Refined Metals Corp. is a fully operational metal reclaiming facility. The site consists of one large multi-story processing building, two large single-story warehouse buildings, a probable heat processing building, and a well-lined holding pond. An opening in the pond's containment wall is visible and would direct any overflow southeast into Sloan Ditch. An open storage area containing drums and probable scrap metal is also present. No spillage is visible at the site.

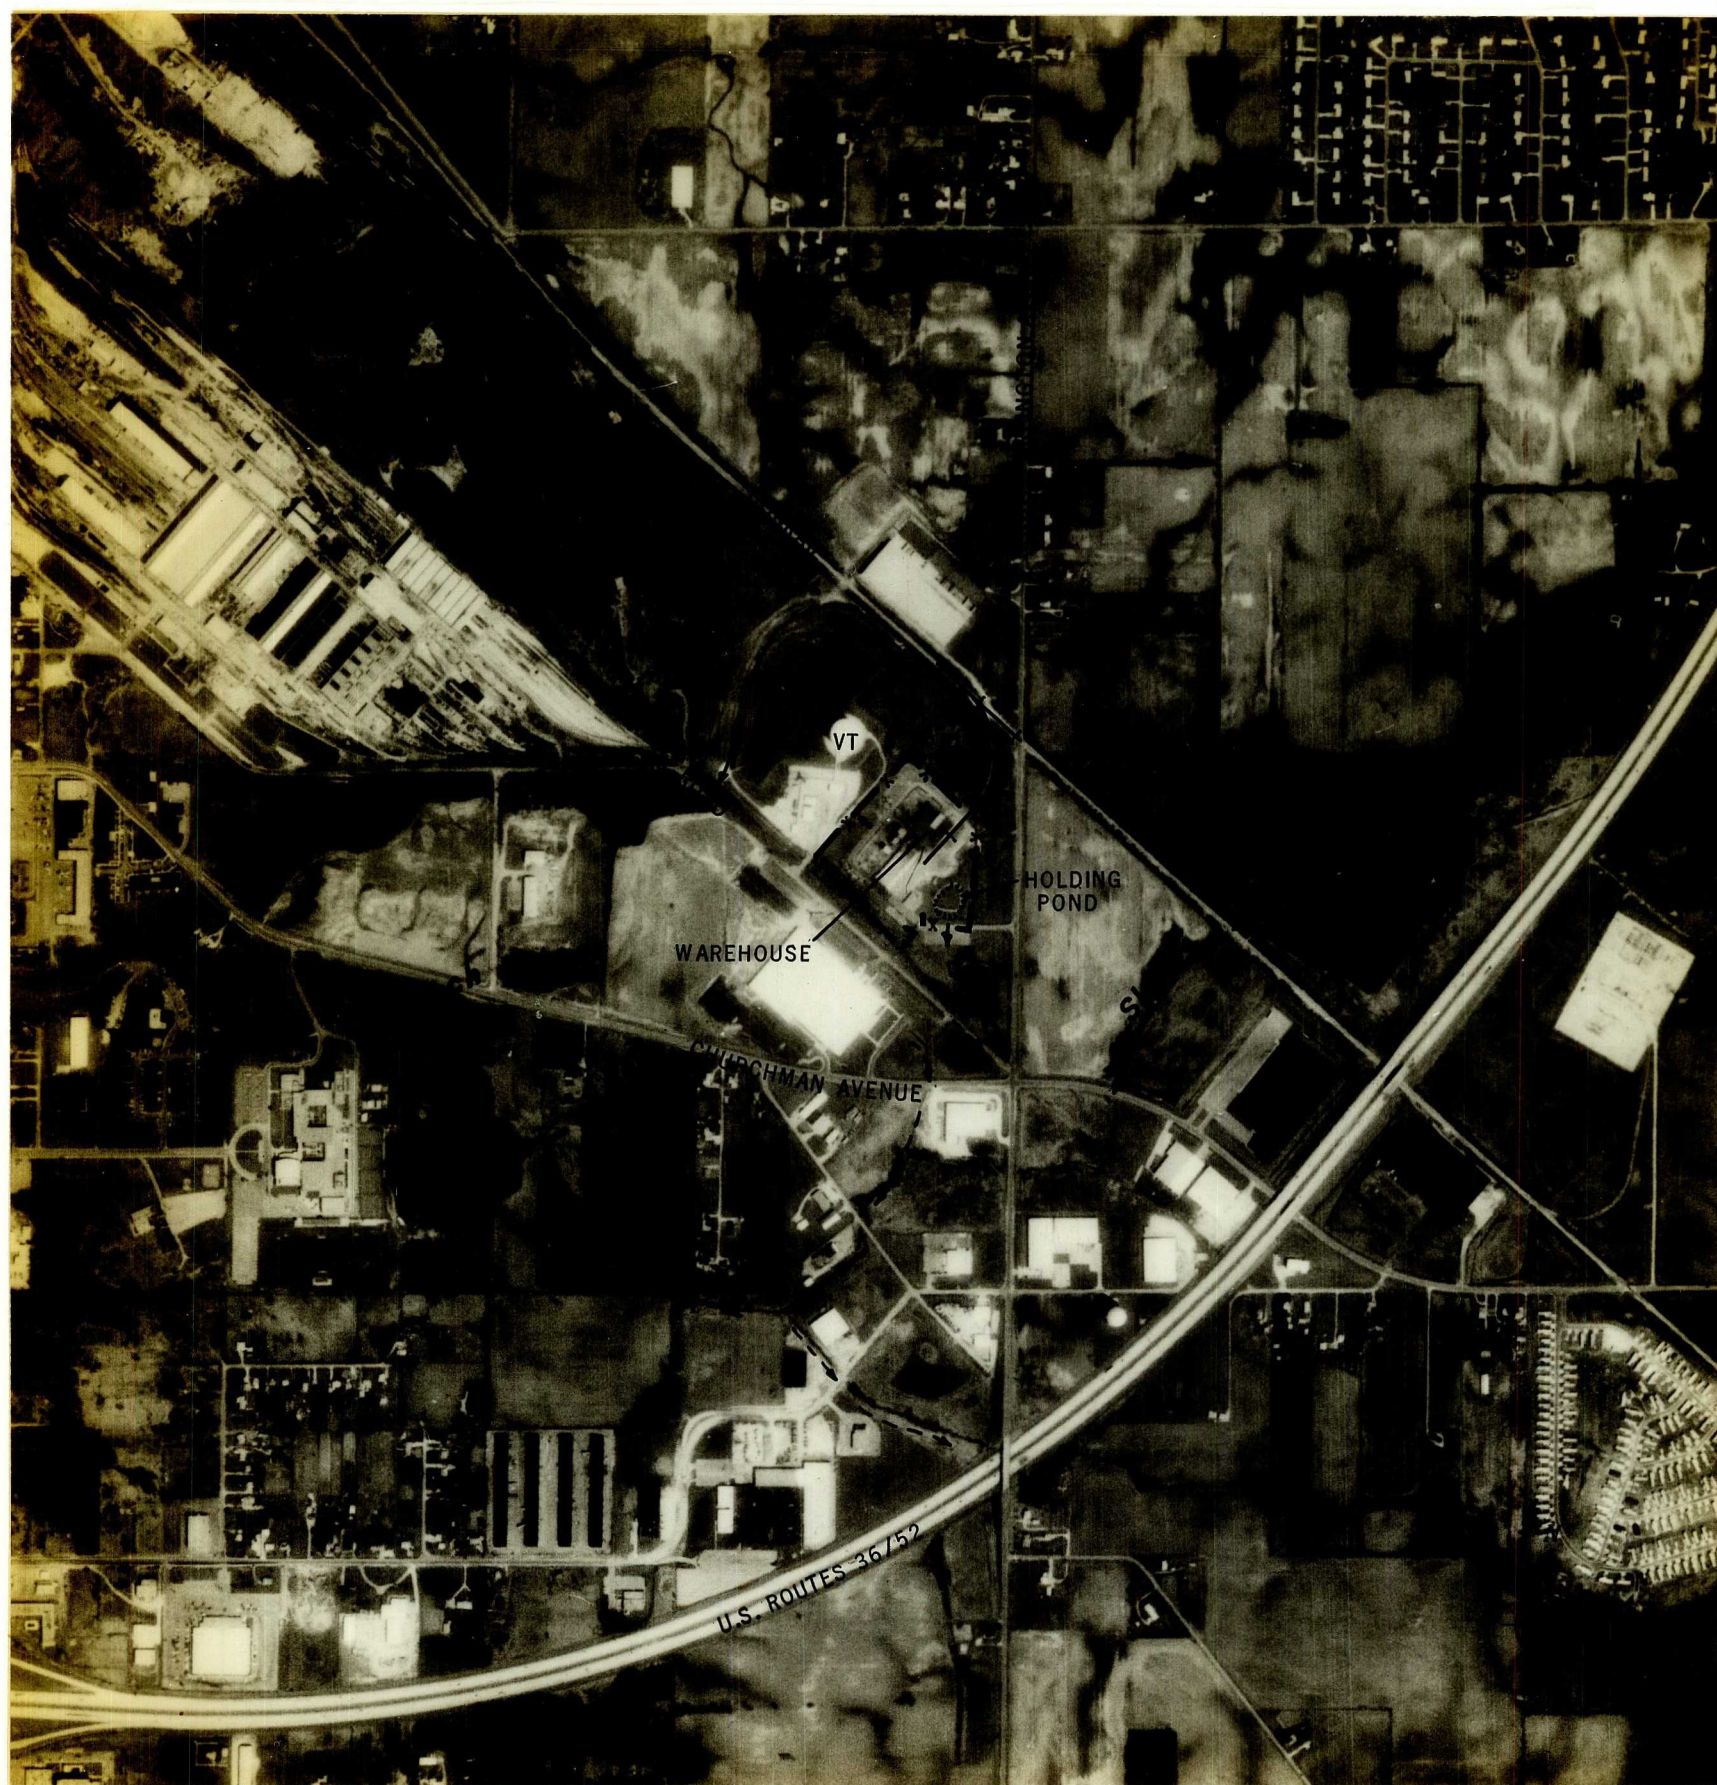
APRIL 16, 1983 (FIGURE 6)

This photo shows the Refined Metals Corp. is operational, although no specific activity is visible. The two warehouses previously identified on the 1971 photo (Figure 5) have become one structure. No open storage of drums or any other material is noted. No vehicles are visible at the site. No other significant changes are noted.

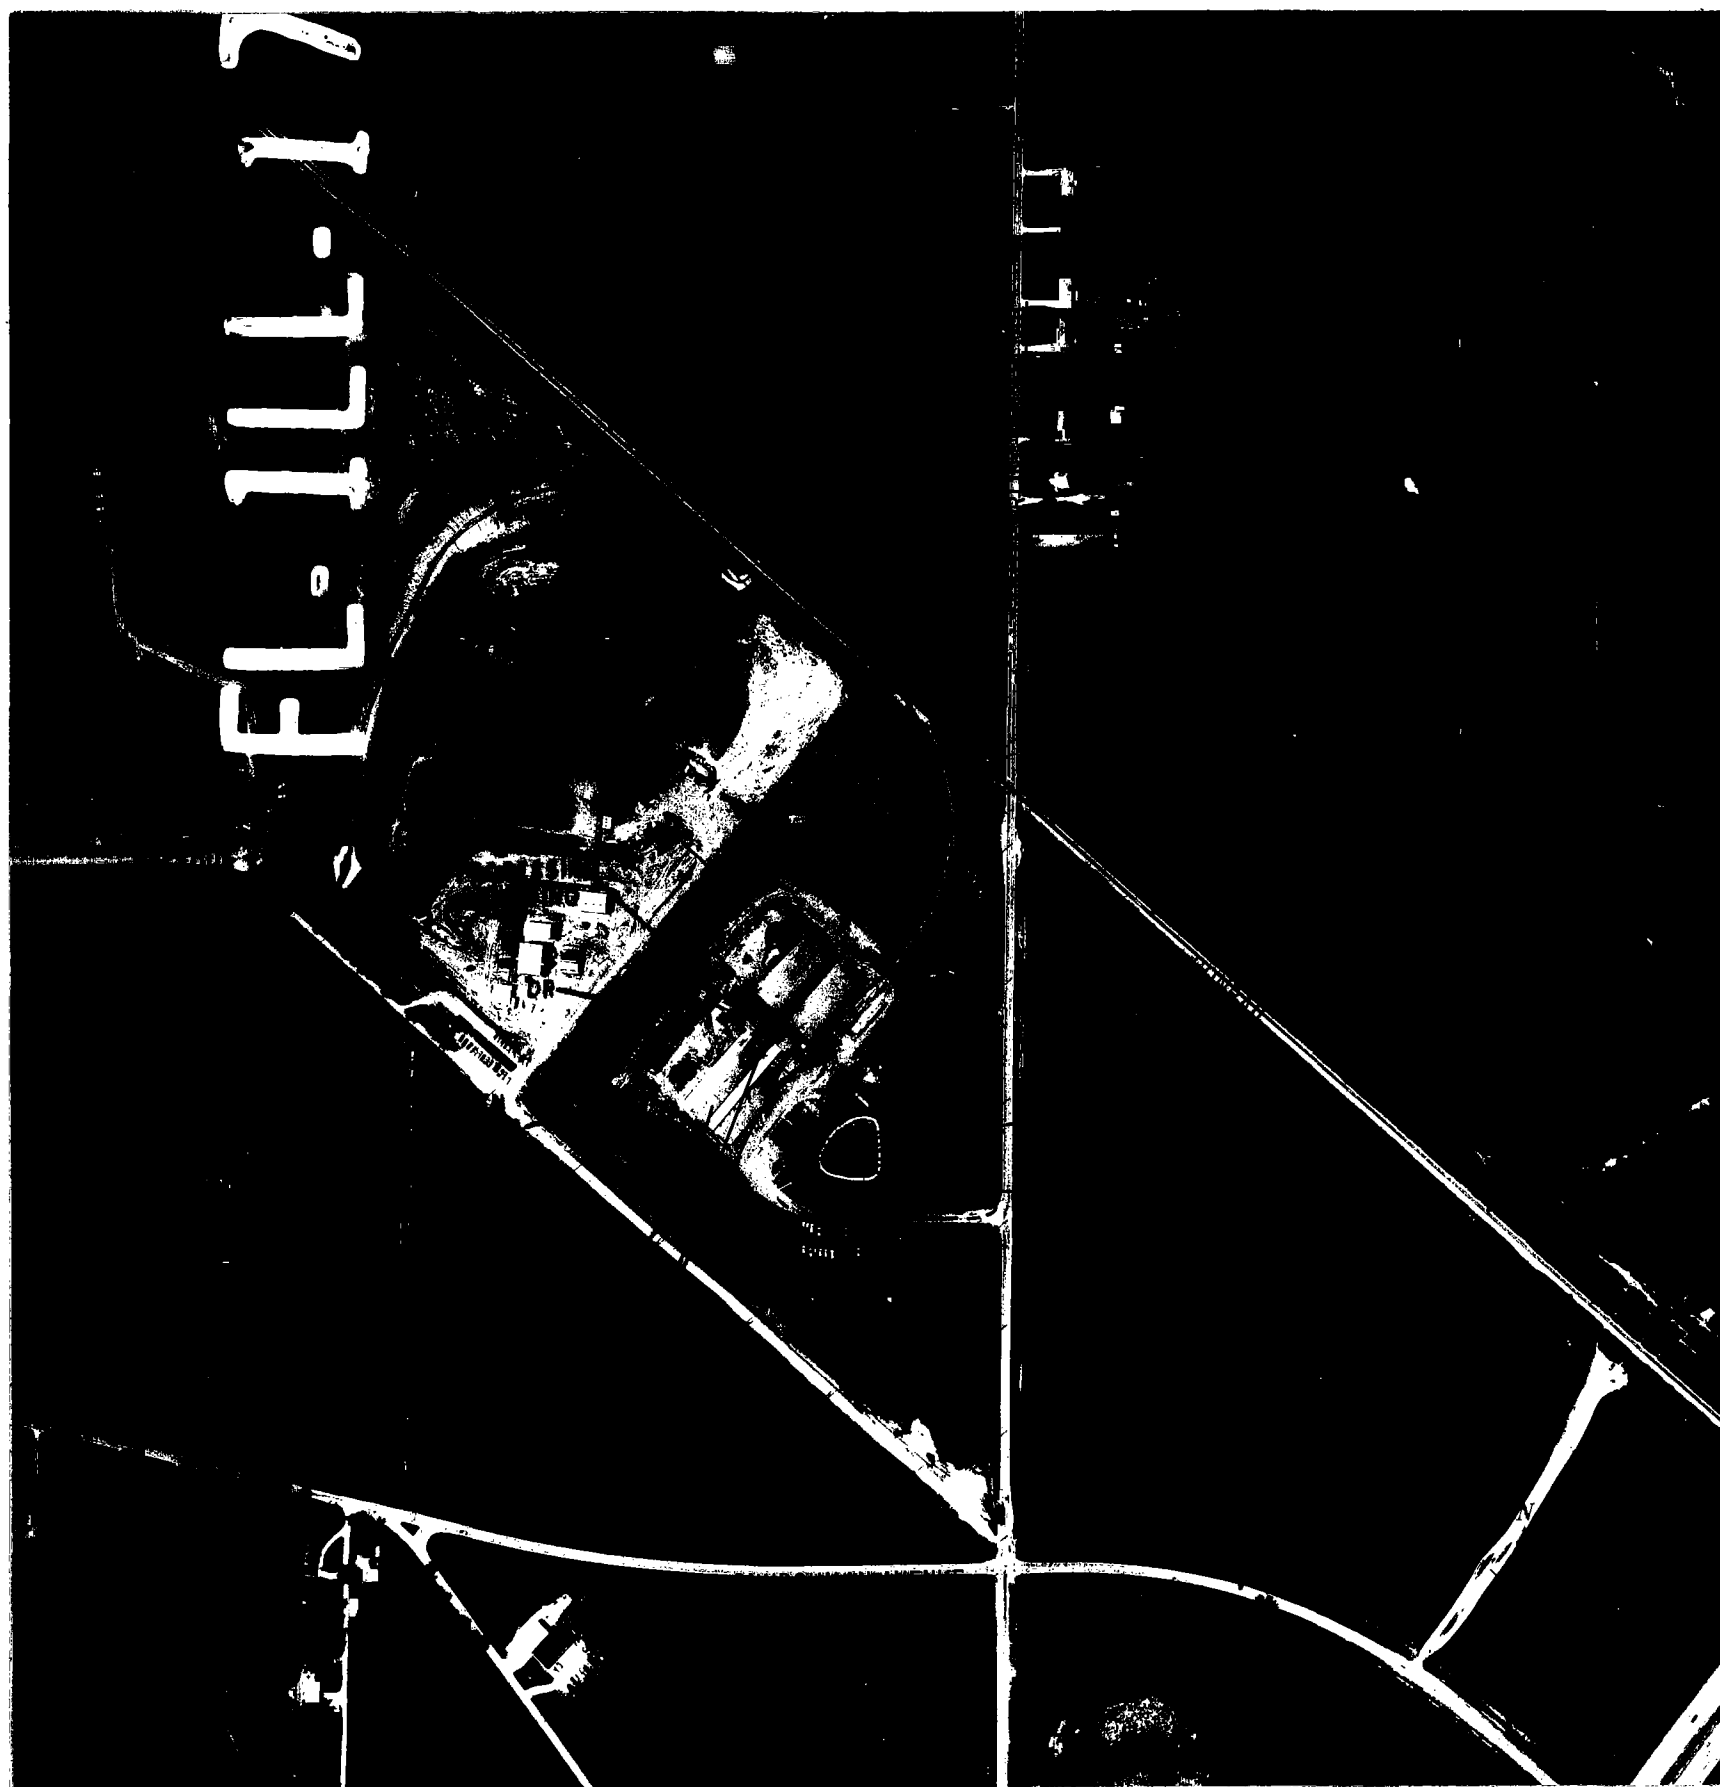
AUGUST 12, 1971 (FIGURE 5)

This photo shows the Refined Metals Corp. is a fully operational metal reclaiming facility. The site consists of one large multi-story processing building, two large single-story warehouse buildings, a probable heat processing building, and a well-lined holding pond. An opening in the pond's containment wall is visible and would direct any overflow southeast into Sloan Ditch. An open storage area containing drums and probable scrap metal is also present. No spillage is visible at the site.

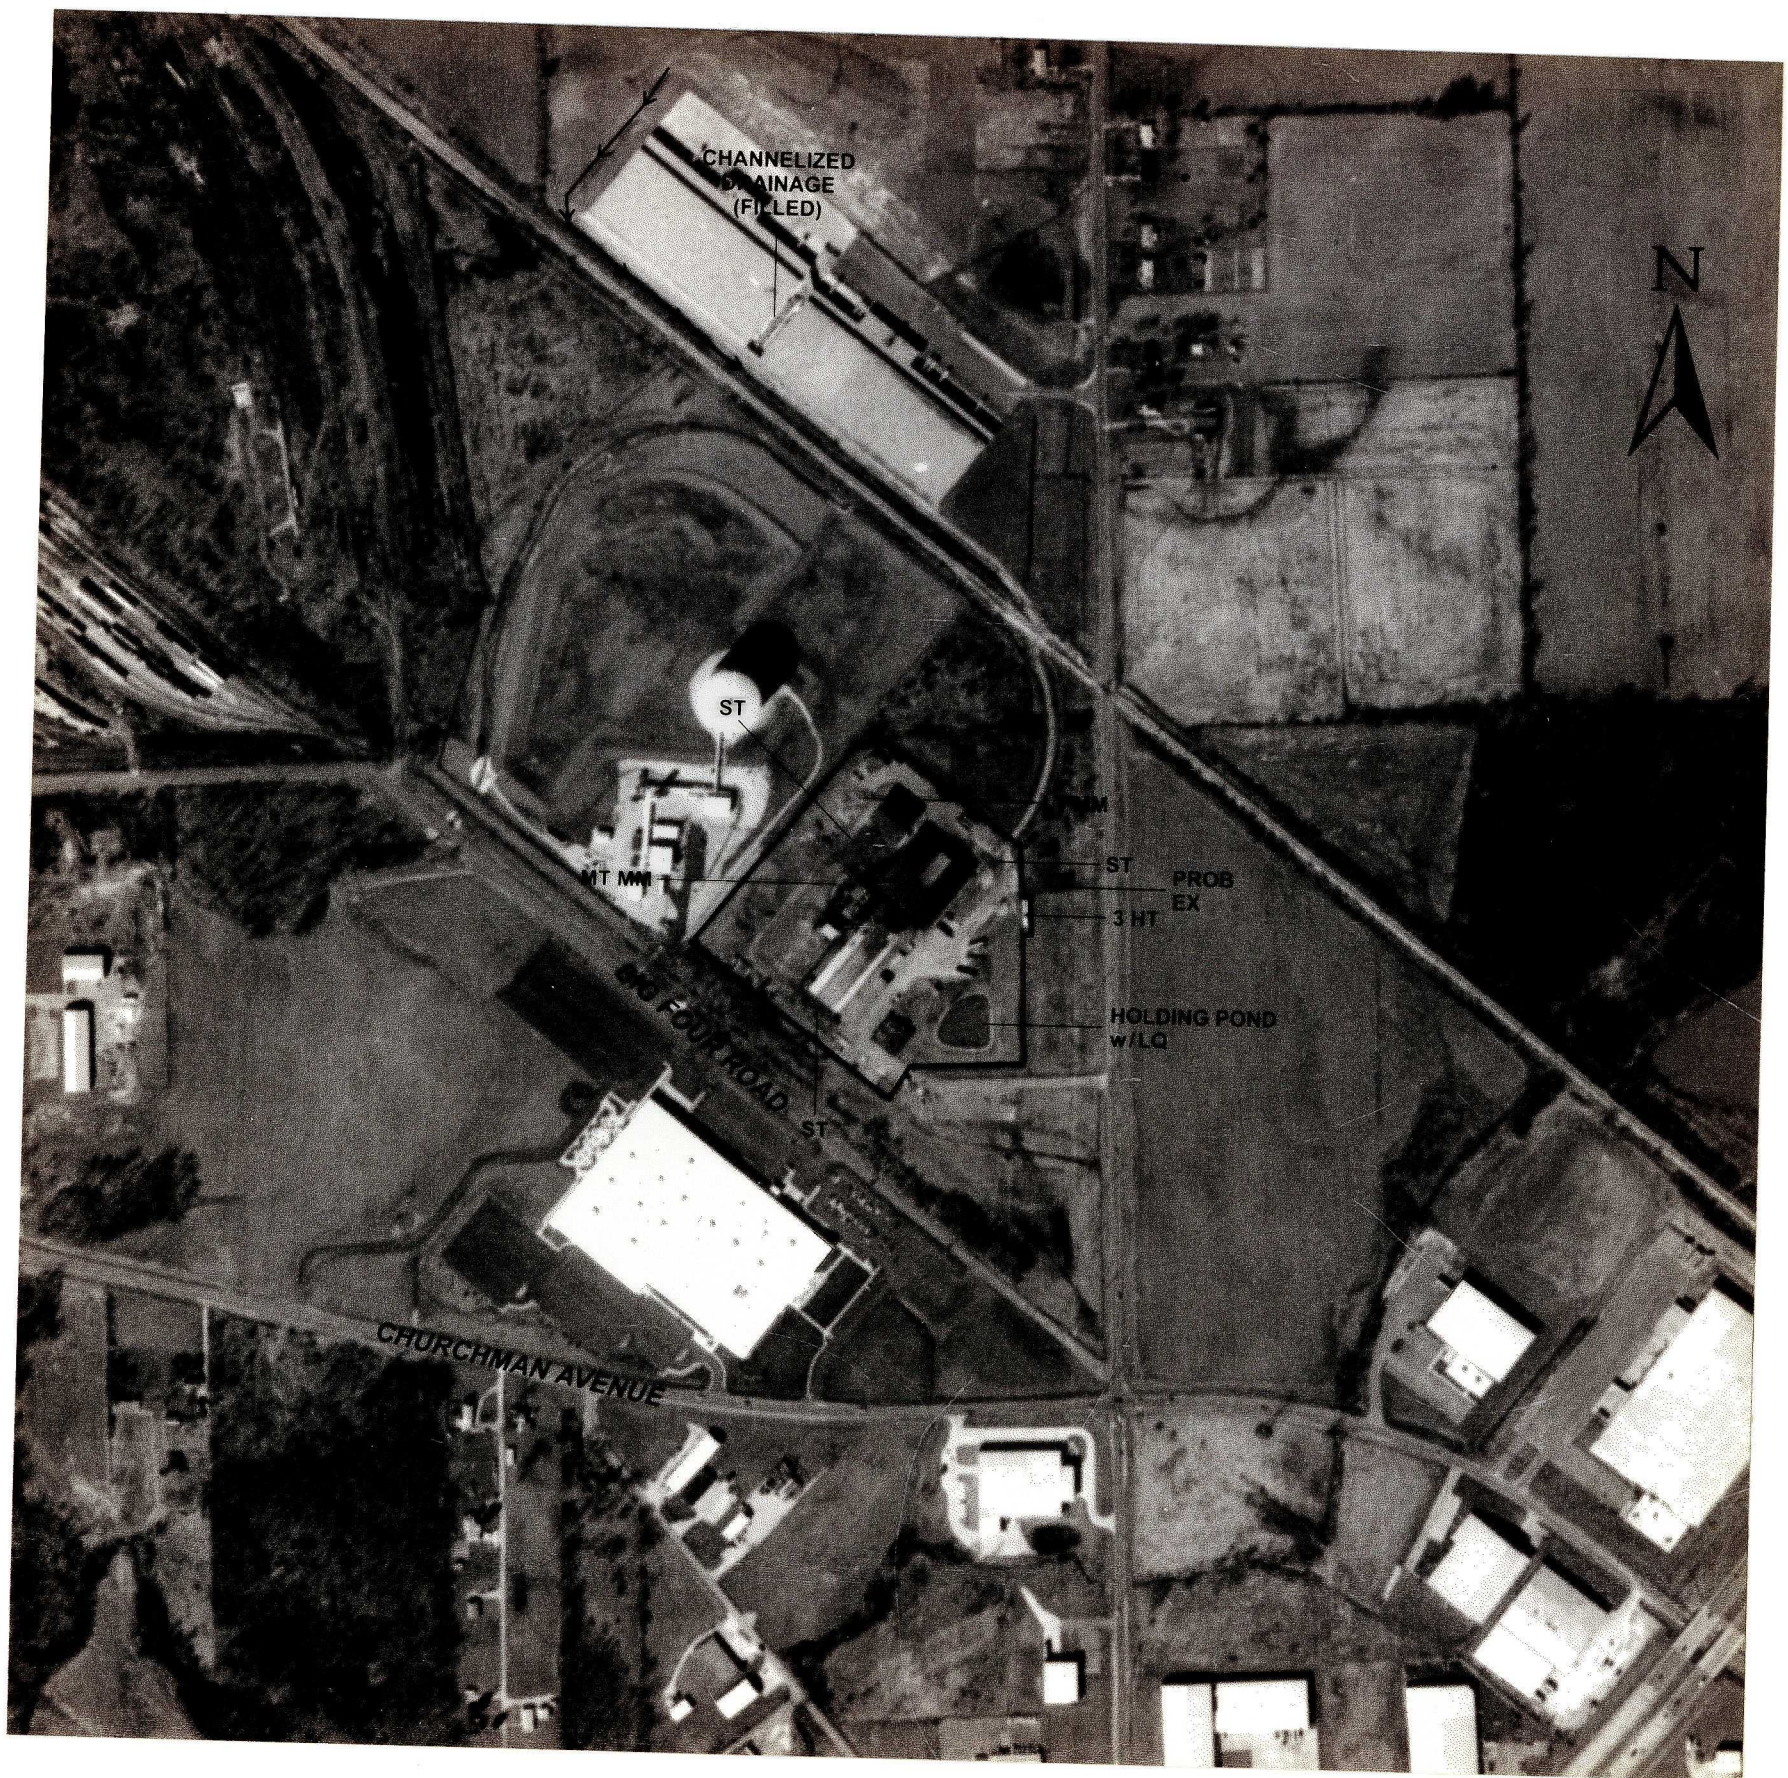
FIGURE 4  
REFINED METALS CORPORATION

According to the United States Geological Survey (USGS) topographic map, Beech Creek is an intermittent stream as it passes southwest of the Refined Metals Corporation site. Two small wetlands are visible immediately outside the northeastern boundary of the Refined Metals Corporation site. A drainage extends south from a holding pond (EPA 1998) located in the southeastern portion of the Refined Metals Corporation site. A channelized drainage is visible adjacent to a wetland southeast of the site. The direction of flow of the drainage is to the south toward Churchman Creek.

Southwest of the site and north of Churchman Avenue four channelized drainages flow into an unnamed south-flowing intermittent stream. East of the Refined Metals Corporation site a small pond drains into the southwest flowing Sloan Ditch. Further south, two channelized drainages flow into Sloan Ditch. Sloan Ditch flows into Churchman Creek south of the Refined Metals Corporation site. Churchman Creek flows into Beech Creek approximately three-quarters of a mile southwest of the site (not visible on this photograph).

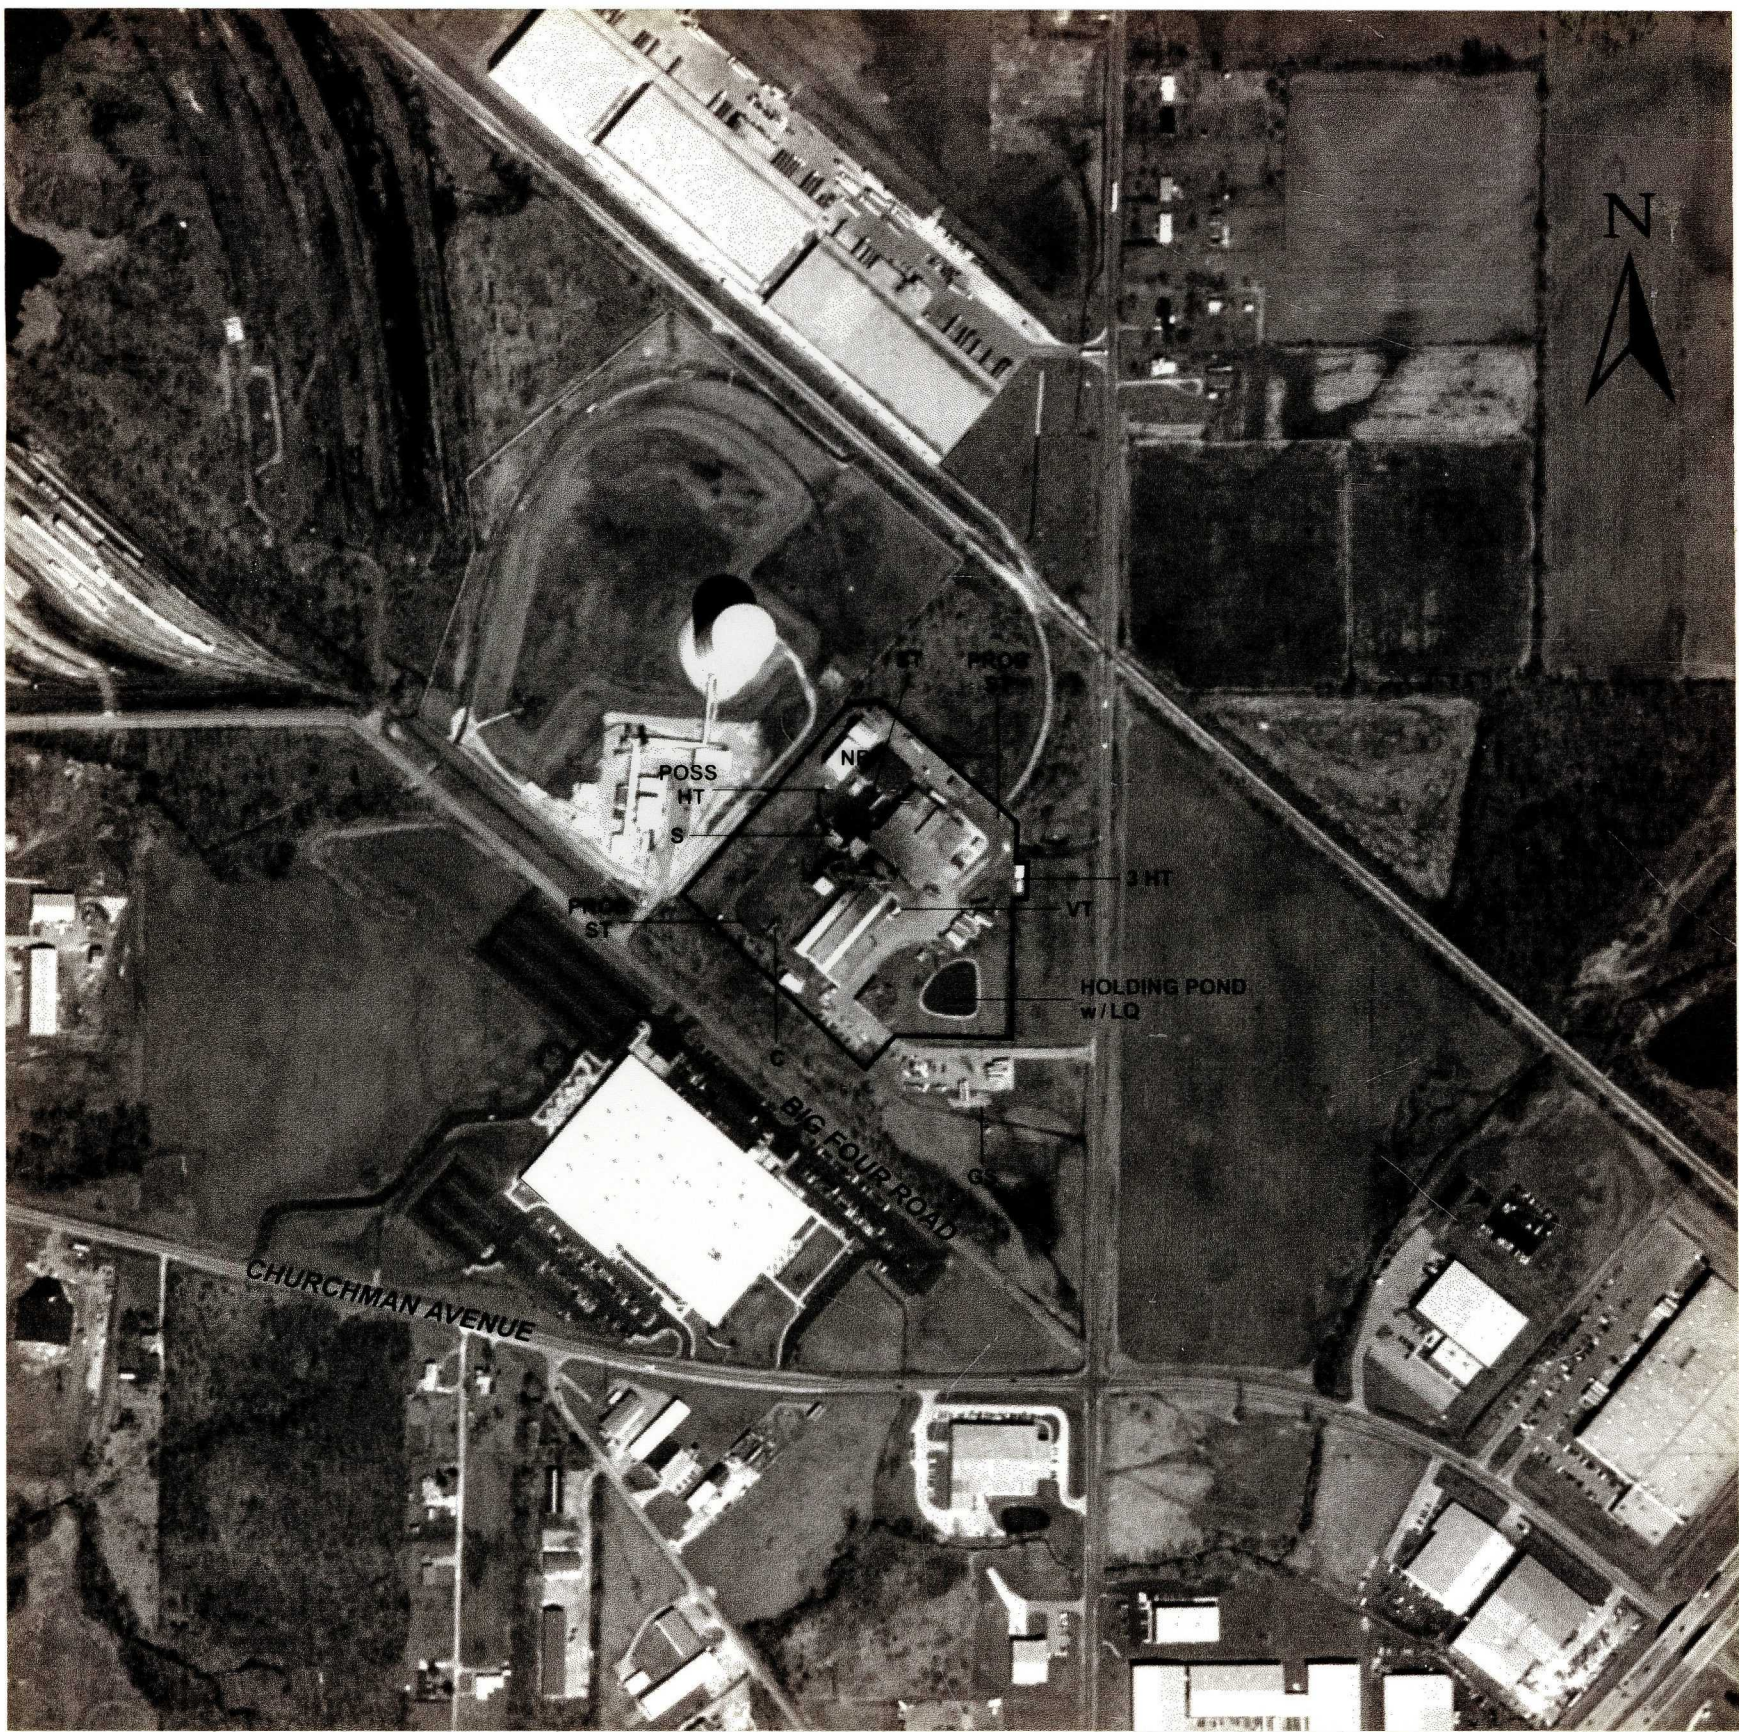
FIGURE 5  
REFINED METALS CORPORATION

The channelized drainages northwest of the Refined Metals Corporation site have been rerouted and filled to accommodate the construction of a new building (not annotated). East of the site one of the two small wetlands seen in 1985 appears to be enlarged by probable excavation (EX) activities.

Light-toned mounded material remains in the northern portion of the site. A stained area remains visible near buildings (not annotated) in the northwestern portion of the site. This area of staining is larger than in 1985. The probable stain, seen in 1985 is no longer visible. A stain is visible in the northeastern corner of the site near the rail spur (not annotated). In the southern portion of the site a stain is visible along an access road (not annotated). The disturbed ground seen in the western portion of the site in 1985 has been graded and is now vegetated. Medium-toned (MT) mounded material is visible alongside a building (not annotated) near the center of the Refined Metals Corporation site. The holding pond with liquid in the southeast portion of the site remains.
